Service Bulletin

Doc.-No.: SB-IS-28B2-AR-01

Service Bulletin SB-IS-28B2-AR-01 applies to all IS-28B2 gliders.

In a number of gliders cracks were detected in the upper stringer of the rear fuselage.

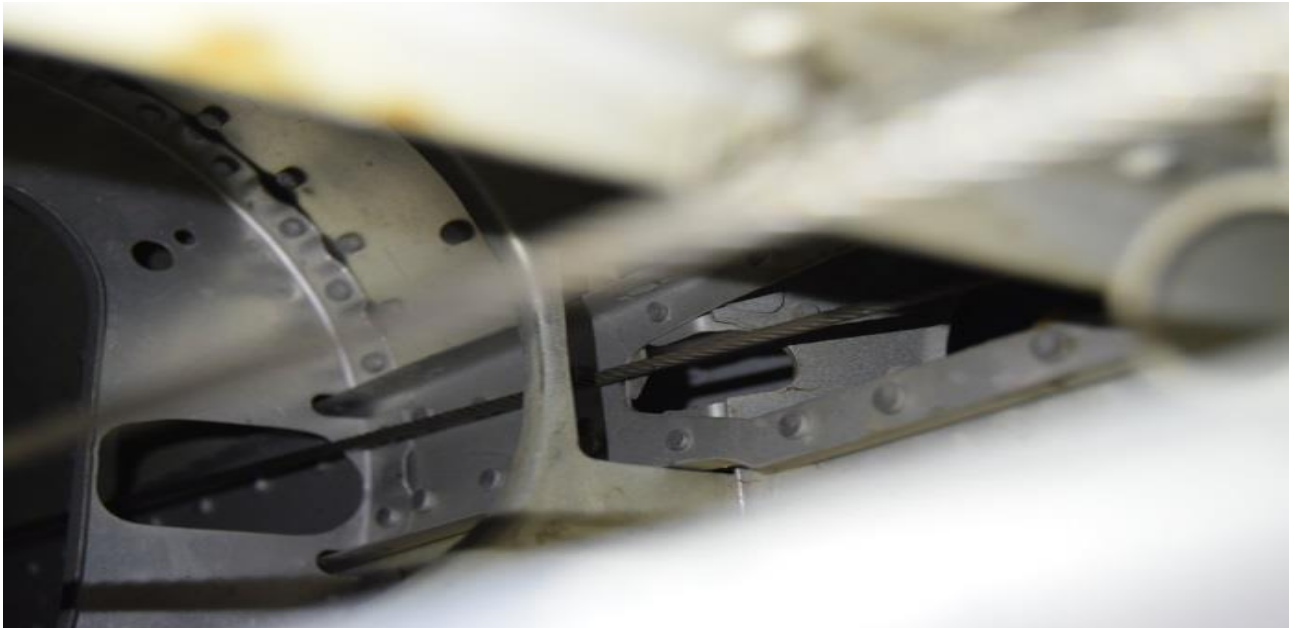
Photo 4

- 3) Special attention shall be paid to the area for cracks, ruptures or corrosions (photo 4).

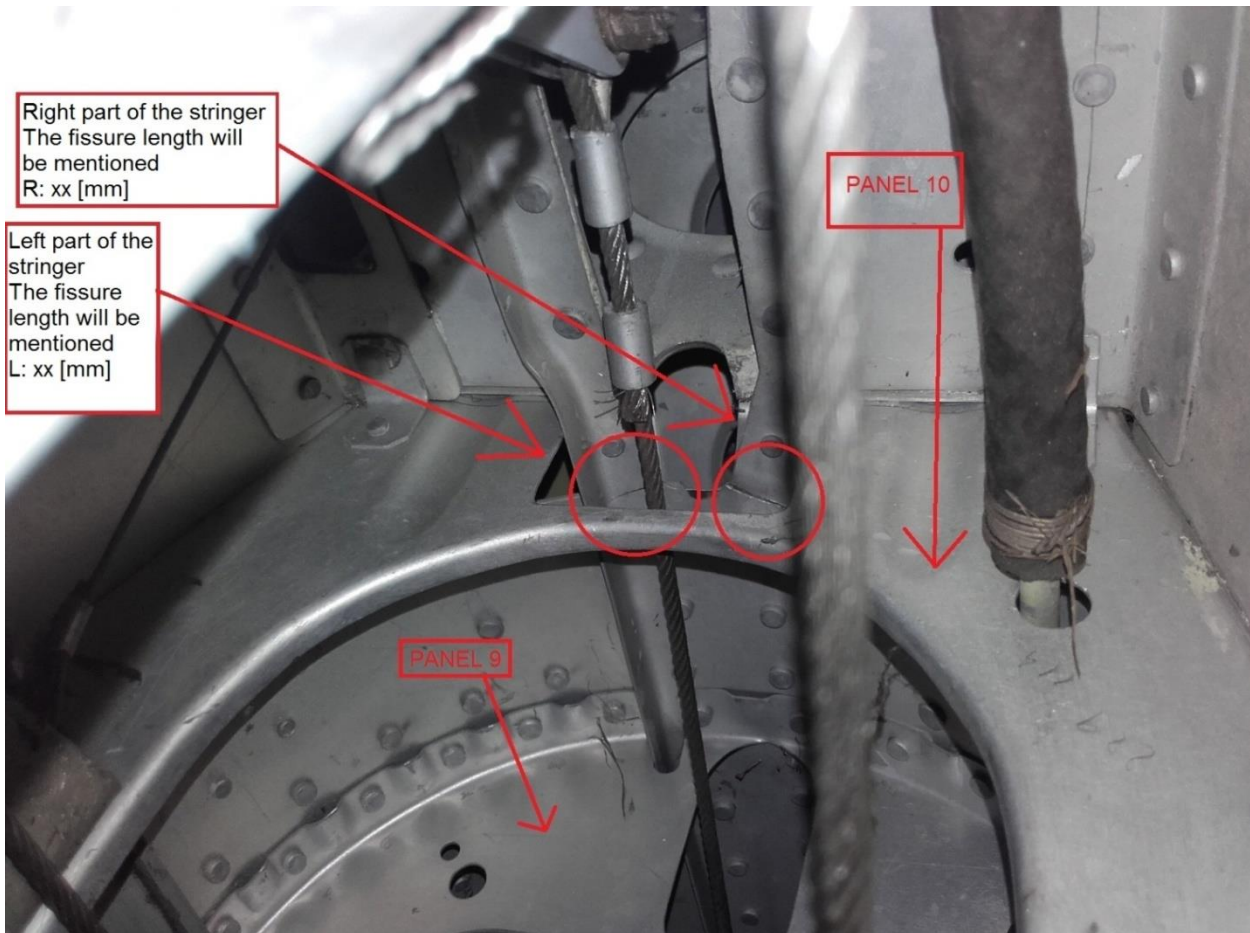
Photo 5

4) If cracks or ruptures are observed (especially in Stringer 30-F01-515), they shall be measured in length (or estimated if measurement is not possible) – photo 5.

2. If no cracks or cracks with a maximum length of less than 5 mm are detected the sailplane shall be inspected every 150 cycles until it has been modified in accordance with SB-IS-28B2-AR-02 (EASA major change approval 10060677).

3. If cracks of more than 5 mm or cracks originating from rivet holes are detected the sailplane shall be grounded until it has been modified in accordance with SB-IS-28B2-AR-02 (EASA major change approval 10060677).
