IS-28M2/GR/CO-04 MANDATORY SERVICE BULLETIN

: IS-28M2/GR MOTOR GLIDER

: CHECKING THE CLEARANCE BETWEEN THE ELEVATOR CONTROL CABLE AND THE FUEL PIPE CONNECTING THE

FUEL TANK TO THE FUEL STRAINER

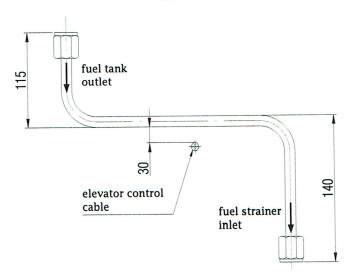
- Look through the fuel strainer inspecțion hole and evaluate the clearance between the elevator control cable and the fuel pipe connecting the fuel tank to the fuel strainer.
 - 1. If the evaluated clearance is of approx. 25 to 35 mm, the mounting is correct.

To eliminate the possibility of a later wrong mounting, mark two arrows with a marker, indicating the fuel flow direction, as shown in the drawing.

2. If the clearance is low (5 to 10mm), remove the fuel pipe and mount it again, but reversed, as shown in the drawing, after having marked the fuel flow direction at both ends-as shown in the drawing.

3. If the clearance is low (5 to 10mm), but after removal a friction mark was found out on the pipe, replace the pipe with a new one delivered by the manufacturing factory, free of charge.
