SERVICE INFORMATION LETTER

SIL-AR-05

(This Service Information Letter contains safety related information for the flight and aircraft)

(Aeroclubul României is the Type Certificate holder for the IS-29D/D2, Club, IS-28B2, IS-30, IS-32A)

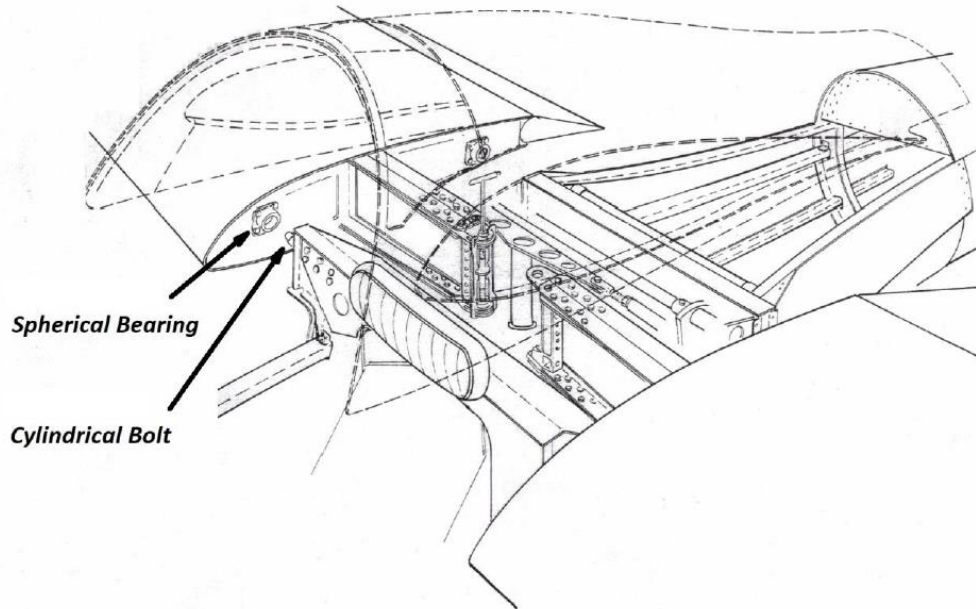
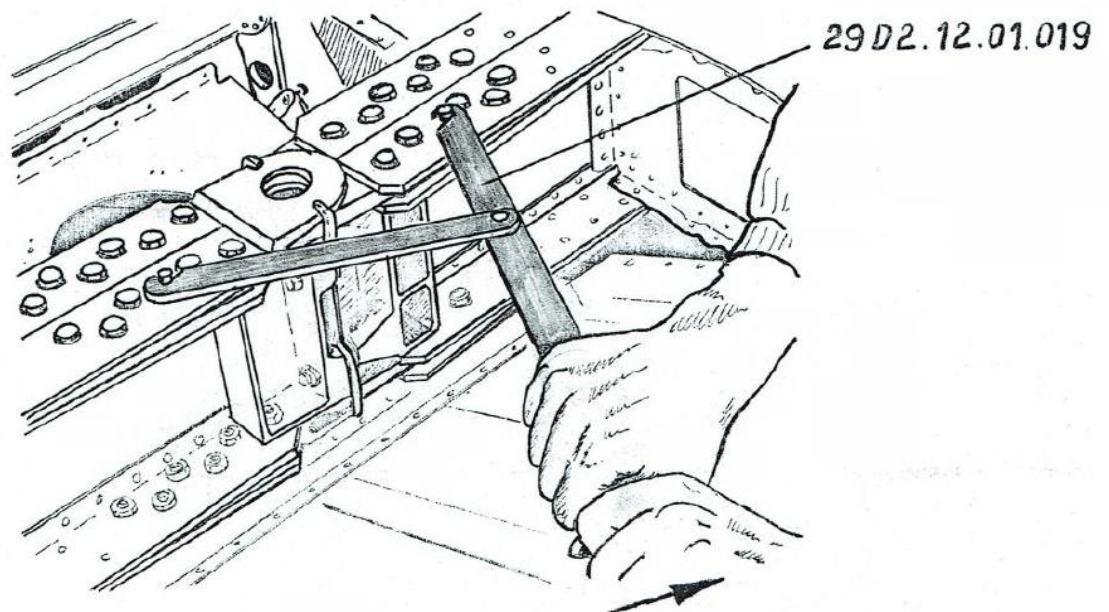
Fig. 1 The rigging procedure

II. Check the tapered bolts position on the drive shaft. The requirement of $a1 - a2 = 0 \pm 2\text{mm}$ must be respected all time. To correct the position of the tapered bolts, the side guide plates must be opened.

VII. Check the complete entrance of the tapered bolts through the strut fittings. There should be: $b1 = b2 = \text{approx. } 2 \text{ mm}$.

Wing closeness rigging Tool

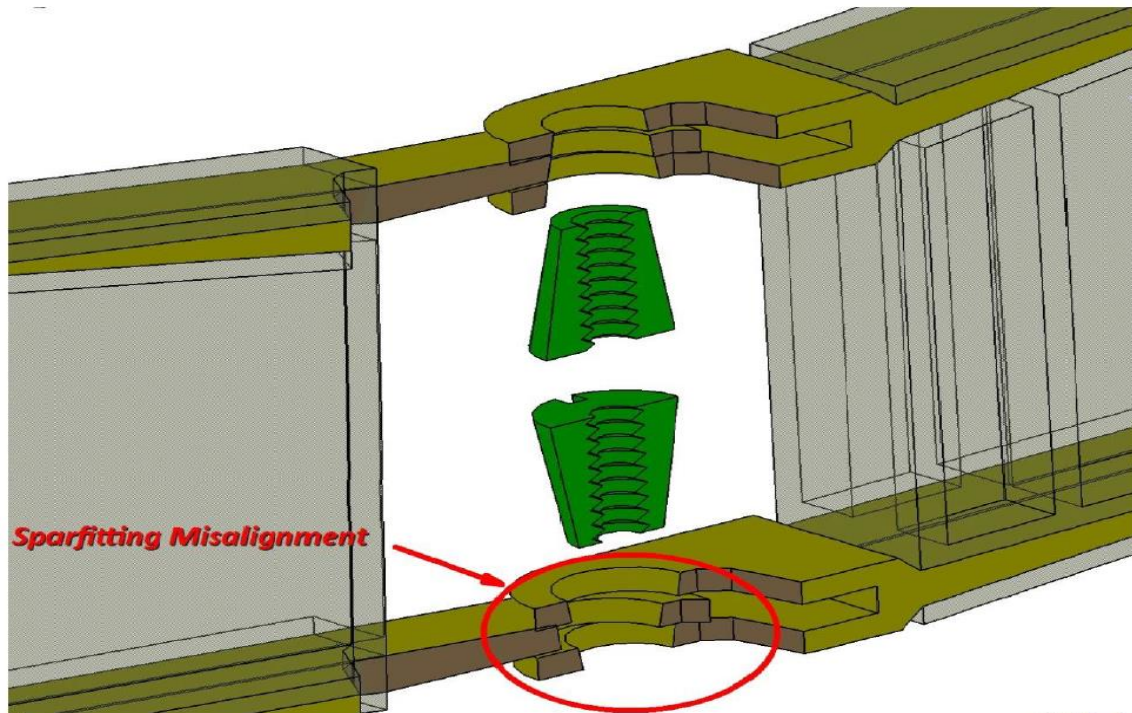
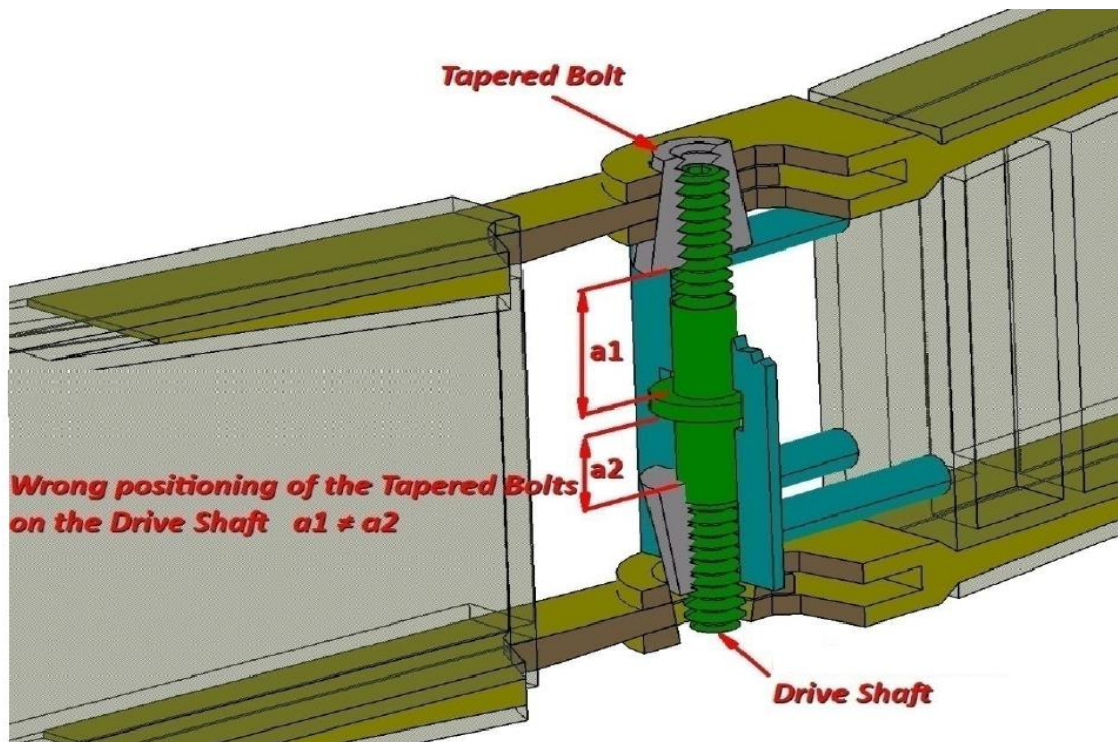
Fig. 2 Incorrect rigging

During a technical flight post maintenance, the mounting part between the wings broke and the right wing partially detached. The incident was described into the Airworthiness Alert 2021-3 IS-28B2 – Wing Rigging Alert issued by The Gliding Federation of Australia Inc.

IX. There are two situations that can lead to a wrong assembly of the Wings:

- The bores from the fittings of the left and right spars are not properly aligned, up and down.
- The position of the tapered bolts is not correct on the drive shaft.

2.a A one-time inspection shall be performed checking the correct mounting of the wings (see the correct mounting procedure on the next pages).

2.b The Maintenance Programme of the glider shall be amended, adding the mounting procedure that must be followed every time the wings are mounted.

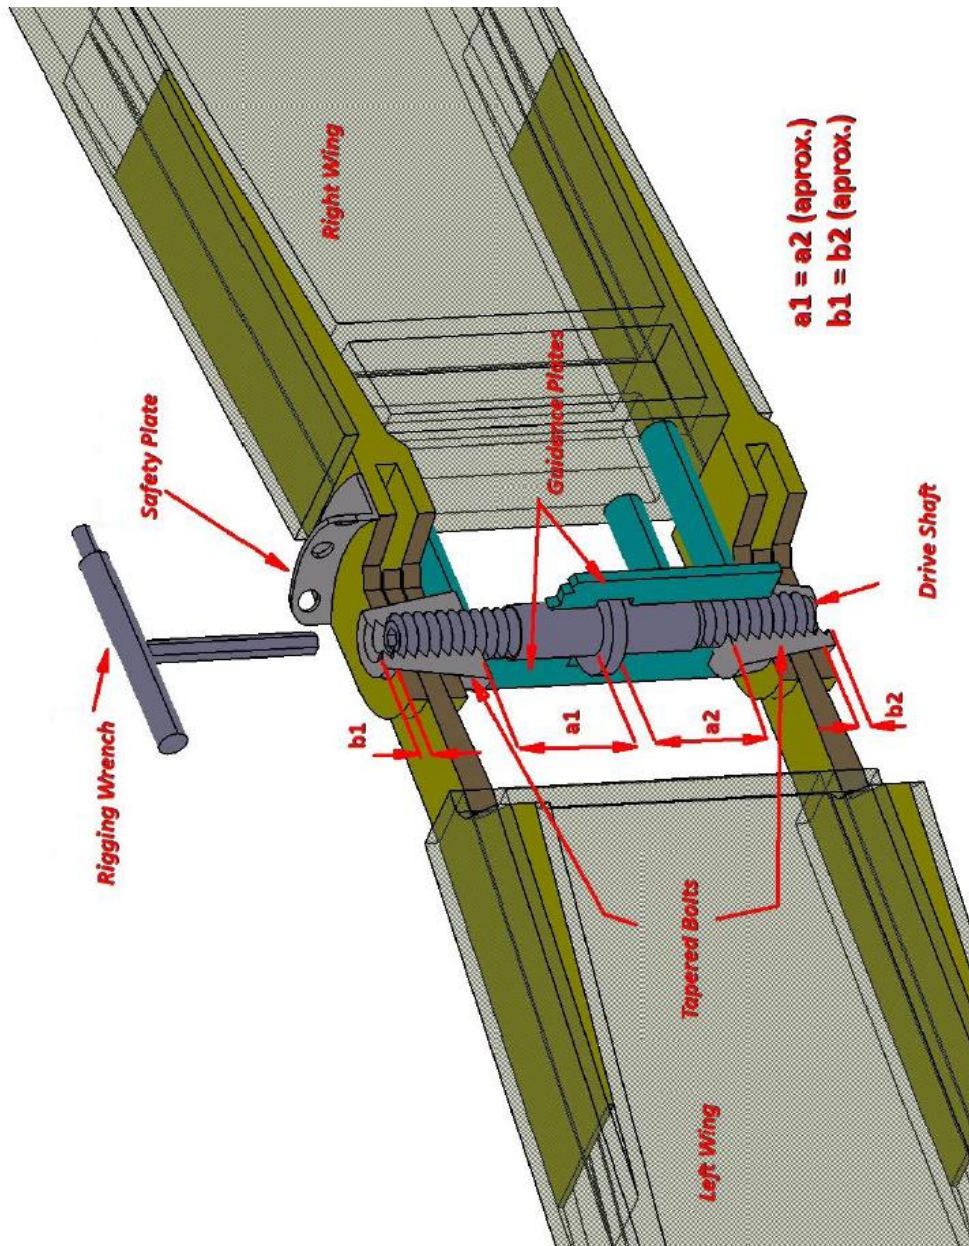
Fig. 3 – Correct rigging

The collar on the drive shaft must be inside the recesses in the guide plates.
