Service Bulletin

Doc.-No.: SB-IS-28B2-AR-01

Service Bulletin SB-IS-28B2-AR-01 applies to all IS-28B2 gliders.

In a number of gliders cracks were detected in the upper stringer of the rear fuselage.

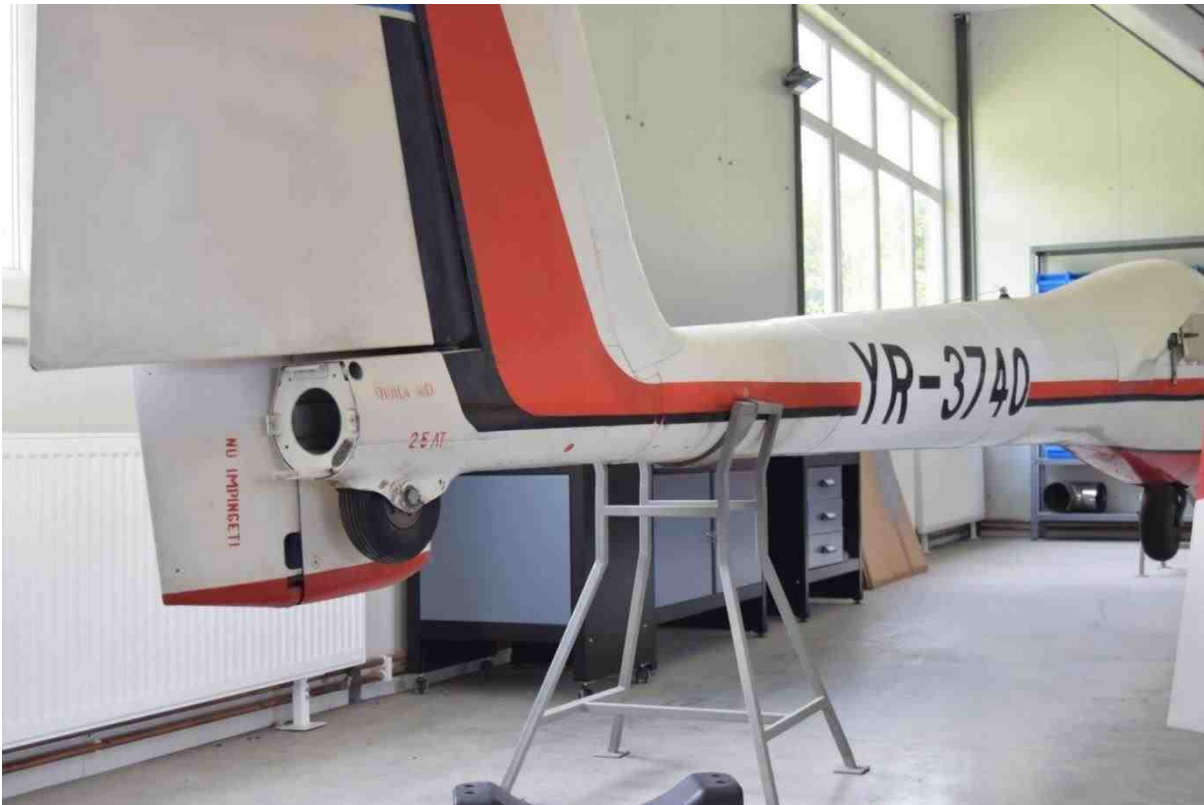
Photo 1

1) Raise the rear fuselage to facilitate easy access to the maintenance panel, for example like in photo 1.

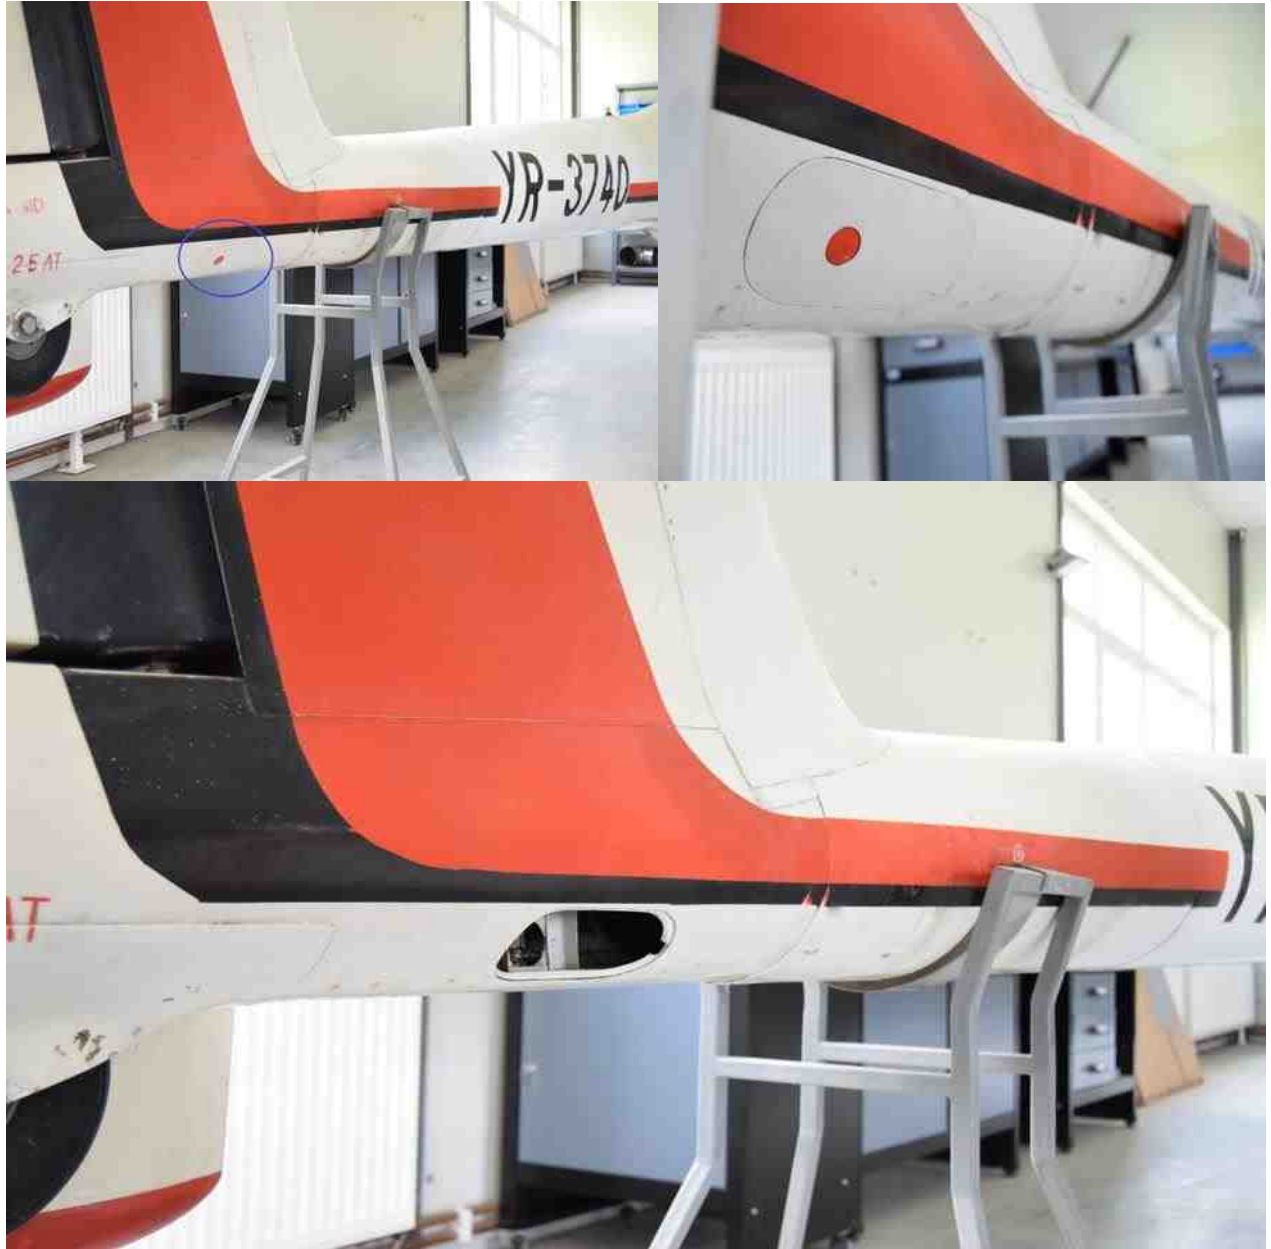
Photo 2

- 2) Remove the maintenance panel to access the maintenance cut out from the bottom of the fuselage, right side, under the vertical stabilizer.

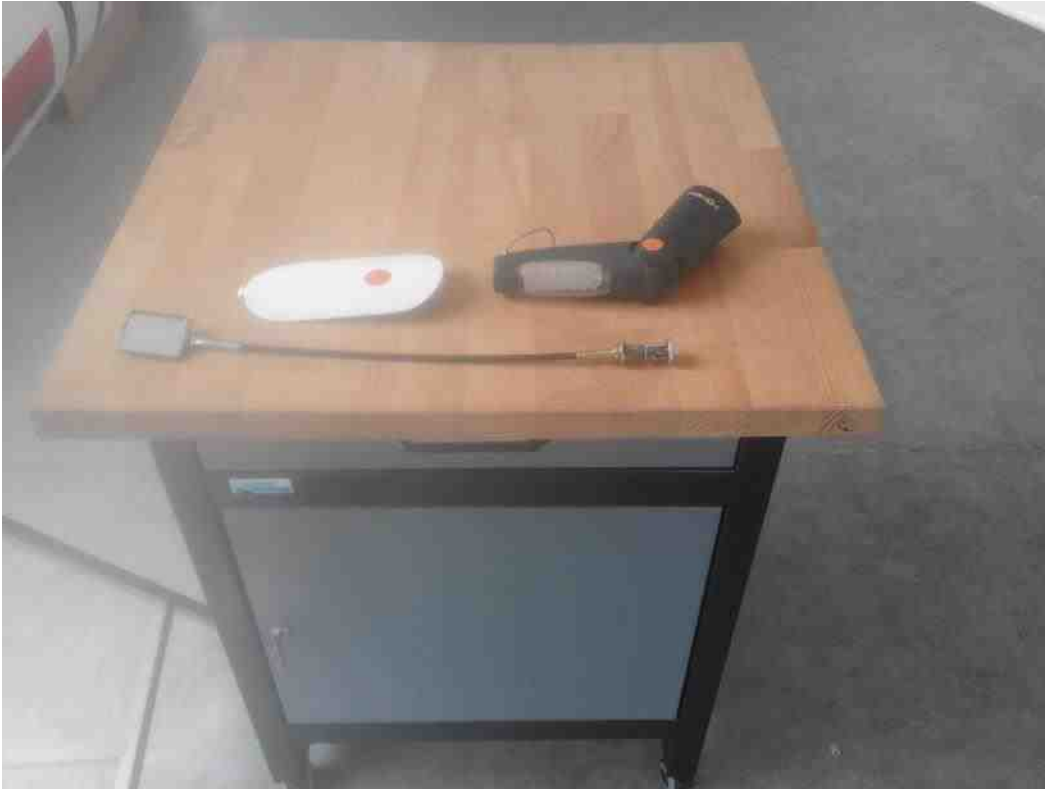
Photo 3

- 1) Use a bright flashlight to inspect the inside of the fuselage.
- 2) Using a retractable mirror and/or a borescope camera (photo bellow), the zone shall be inspected.

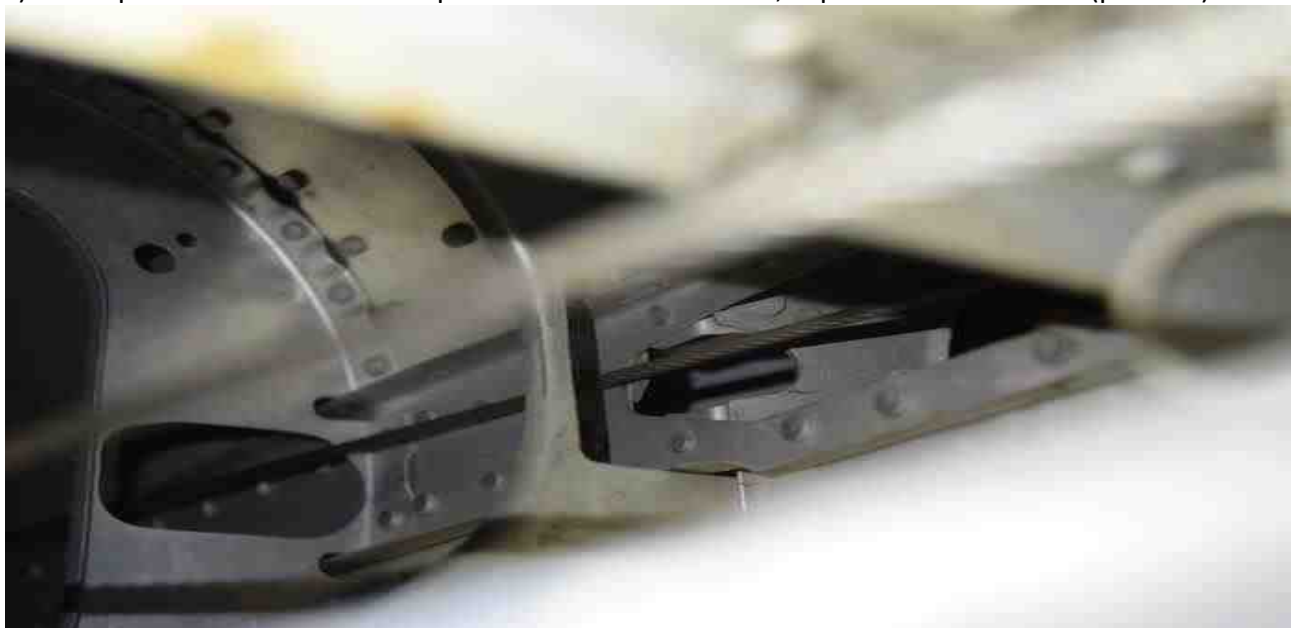
Photo 4

- 3) Special attention shall be paid to the area for cracks, ruptures or corrosions (photo 4).

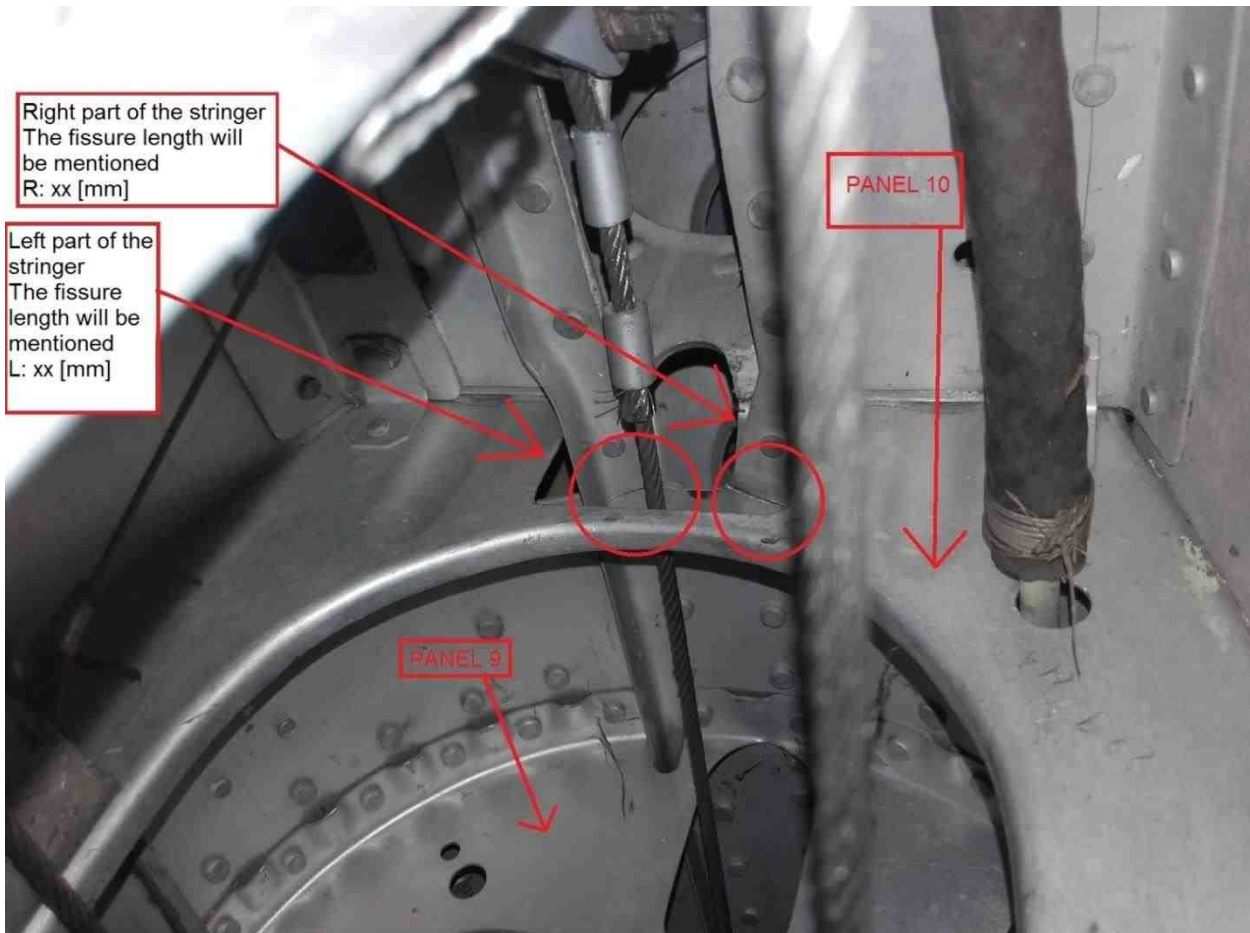
Photo 5

4) If cracks or ruptures are observed (especially in Stringer 30-F01-515), they shall be measured in length (or estimated if measurement is not possible) – photo 5.

2. If no cracks or cracks with a maximum length of less than 5 mm are detected the sailplane shall be inspected every 150 cycles until it has been modified in accordance with SB-IS-28B2-AR-02 (EASA major change approval 10060677).

3. If cracks of more than 5 mm or cracks originating from rivet holes are detected the sailplane shall be grounded until it has been modified in accordance with SB-IS-28B2-AR-02 (EASA major change approval 10060677).
