Service Information Letter	Doc.-No.: SIL- AR-01
		Revision: 01
		Date: 06.11.2018
EASA AP439		Page 1 of 4

SIL Service Information Letter

Subject: Joint Qucik Connectors (L'Hotellier ball and swivel) installed on gliders and sailplanes

Models Affected: IS 28B2 - all serial numbers

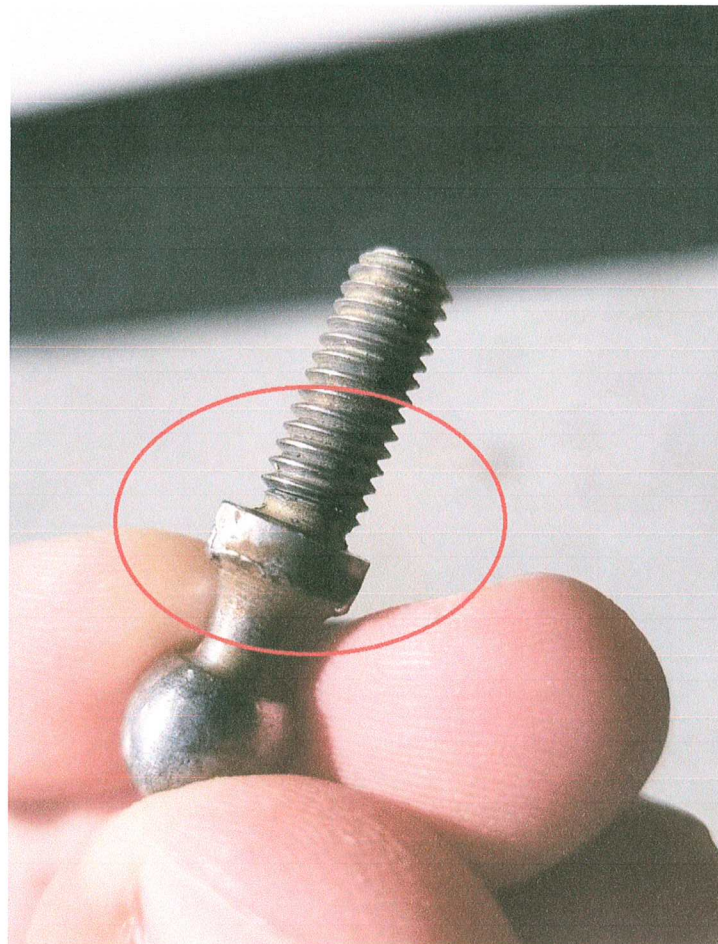
Fig. 1

It has been reported by the user, that during exploitation of one IS 28B2 sailplane the ball joint (rotule) from joint quick connector of the flap command chain had broken immediatly after landing (**see fig.1**). The glider landed safely.

For safety reasons and to eliminate future failures strongly suggest to implement the following actions:

For all gliders type IS 28B2 (Twin Lark), IS 29D2 (Lark) and IS 32 with L'Hotellier ball and swivel joint quick connectors, **BEFORE NEXT FLIGHT:**

1. Unmount the fairing/cover between the wings (**see fig.2** for IS 28B2 example)
2. Check all L'Hotellier ball and swivel joint as described in L'Hotellier document "Instruction for the maintenance of L'Hotellier ball and swivel joints"
REF IMA10.001 Rev.F 10.03.2009.
3. Unmount all ball joints from the pieces in which is screwed in and check the ball using a x10 magnifier for cracks, ruptures, corrosion and general state giving special attention under ball and where the screw thread ends. (**see fig.3**)
In case of uncertainty, use other NDT methods.
No thread damage is acceptable.
In case of cracks, ruptures, corrosion and poor general state, replace the piece.

4. Reassembly the ball perfectly set on its base. Fix the ball in position with an adequate locking device.
5. Mount the fairing/cover between the wings according to the Flight and Maintenance Manual.
6. Before first flight of every day, perform a positive check for the flight controls that use L'Hotellier ball and swivel joints, according to EASA SIB 2012-04.
