MANDATORY SERVICE BULLETIN

IS-28B2/EO-12

PRODUCT : IS-28B2

OBJECT : ADDITIONAL INSTRUCTIONS CONCERNING THE
FLYING CONTROLS CHECK.

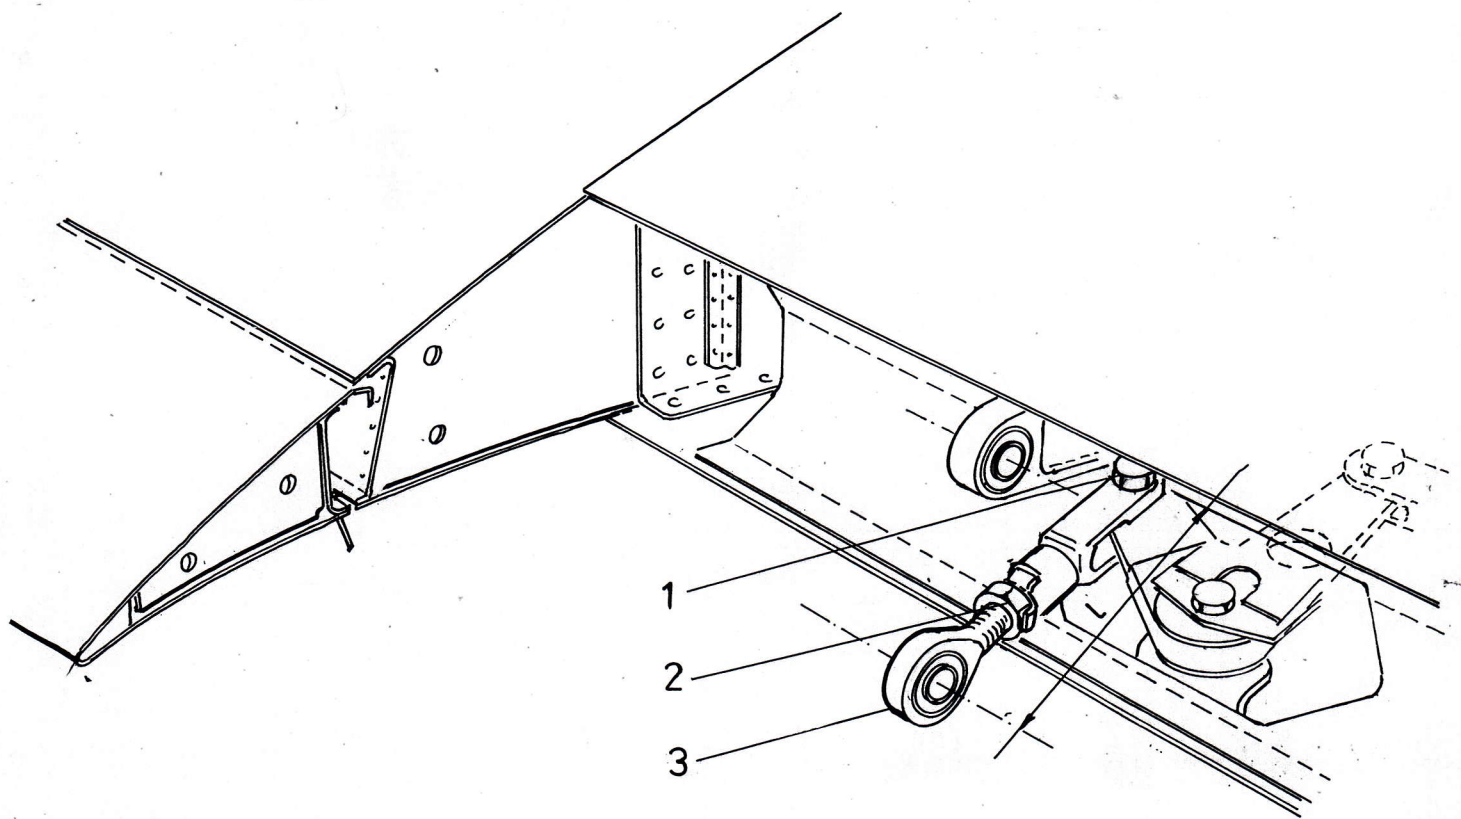
Fig. 1

- In case of incorrect ground handling, if ailerons are forced, or if during an aerobatic flight following a maneuvering incorrectly carried-out, the glider performs a tail slide and the control column is slipped from hand or is suddenly deflected up to the limiter, an additional stress may occur within the ailerons control. In this case the hinge moment created can deflect the ailerons upwards, above the rated deflection of 28° and when an angle of approx. 40° is reached, an additional bending stress occurs on the control rod connected to the ailerons

Visually check the control rod actuating the ailerons, after its removing from wing and replace it with a new one if bent.

Visually check the control rod, proceeding as follows;
(see figure 1, page 6/6).

- (a). Remove the control rod from the wing lever by unlocking and by removing the nut and screw (item 1) ;
- (b). Measure the control rod length between the attachment pins axles at ends (size "1") - to avoid some possible later adjustments ;
- (c). Unlock the nut (item 2) and remove the eye (item 3).
- (d). Visually check the eye: if bent, replace it with a new one.
- (e). Reassemble the parts, in reverse order, adjusting the rod length to size "1".

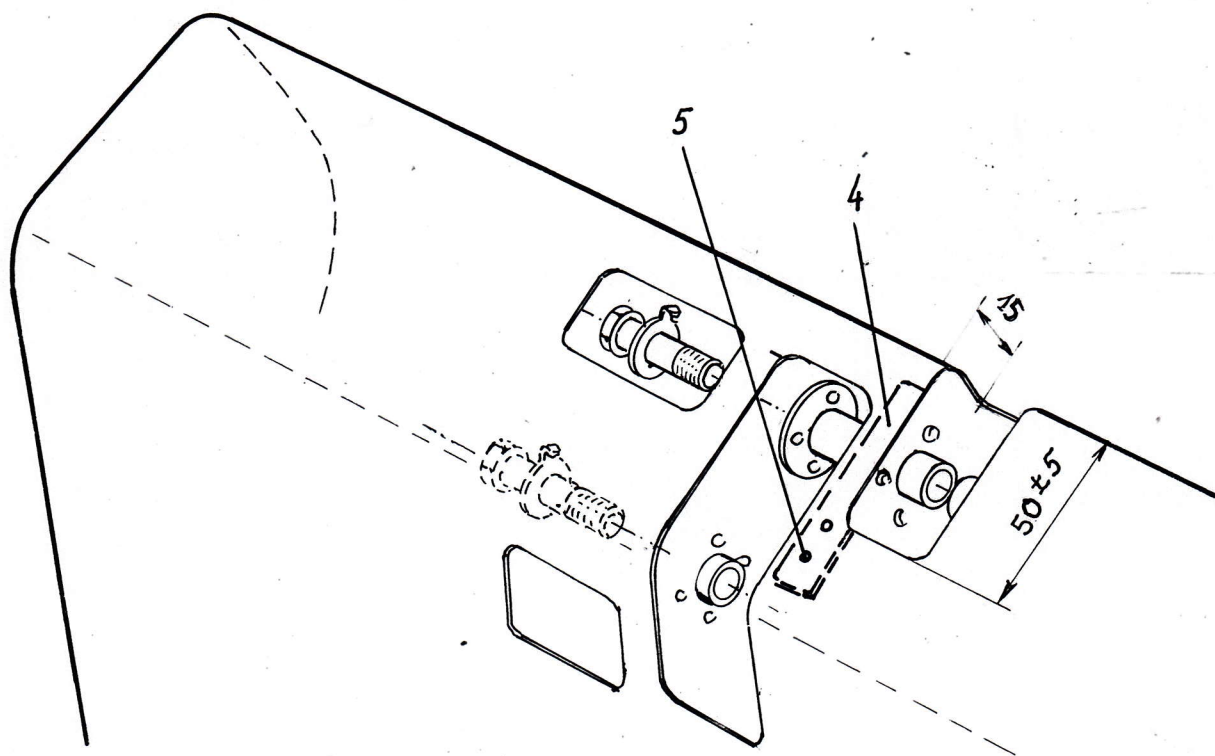
Fig. 2

Enlarge the cut-out in the aileron leading edge (through which the above mentioned rod passes) according to the dimensions on page 6/6 figure 2.

Enlarge the cut-out in the ailerons leading edge to the dimensions indicated on page 6/6, figure 2, by using a mill. Check the doubler item 4 (fig. 2) riveting to the skin. The number of rivets item 5 (fig. 2) shall not be reduced by milling to less than 2 (if required, a new rivet shall be driven in). If the recommended modification is also applied to point C, third paragraph, the original rod is replaced with a new one, (made of steel), after having been adjusted to the length "1". If, applying the point d) above, the eye is found distorted and the Buyer does not possess a spare part, on request, all the rods (made of steel) shall be delivered, applying thus directly the recommended modification.

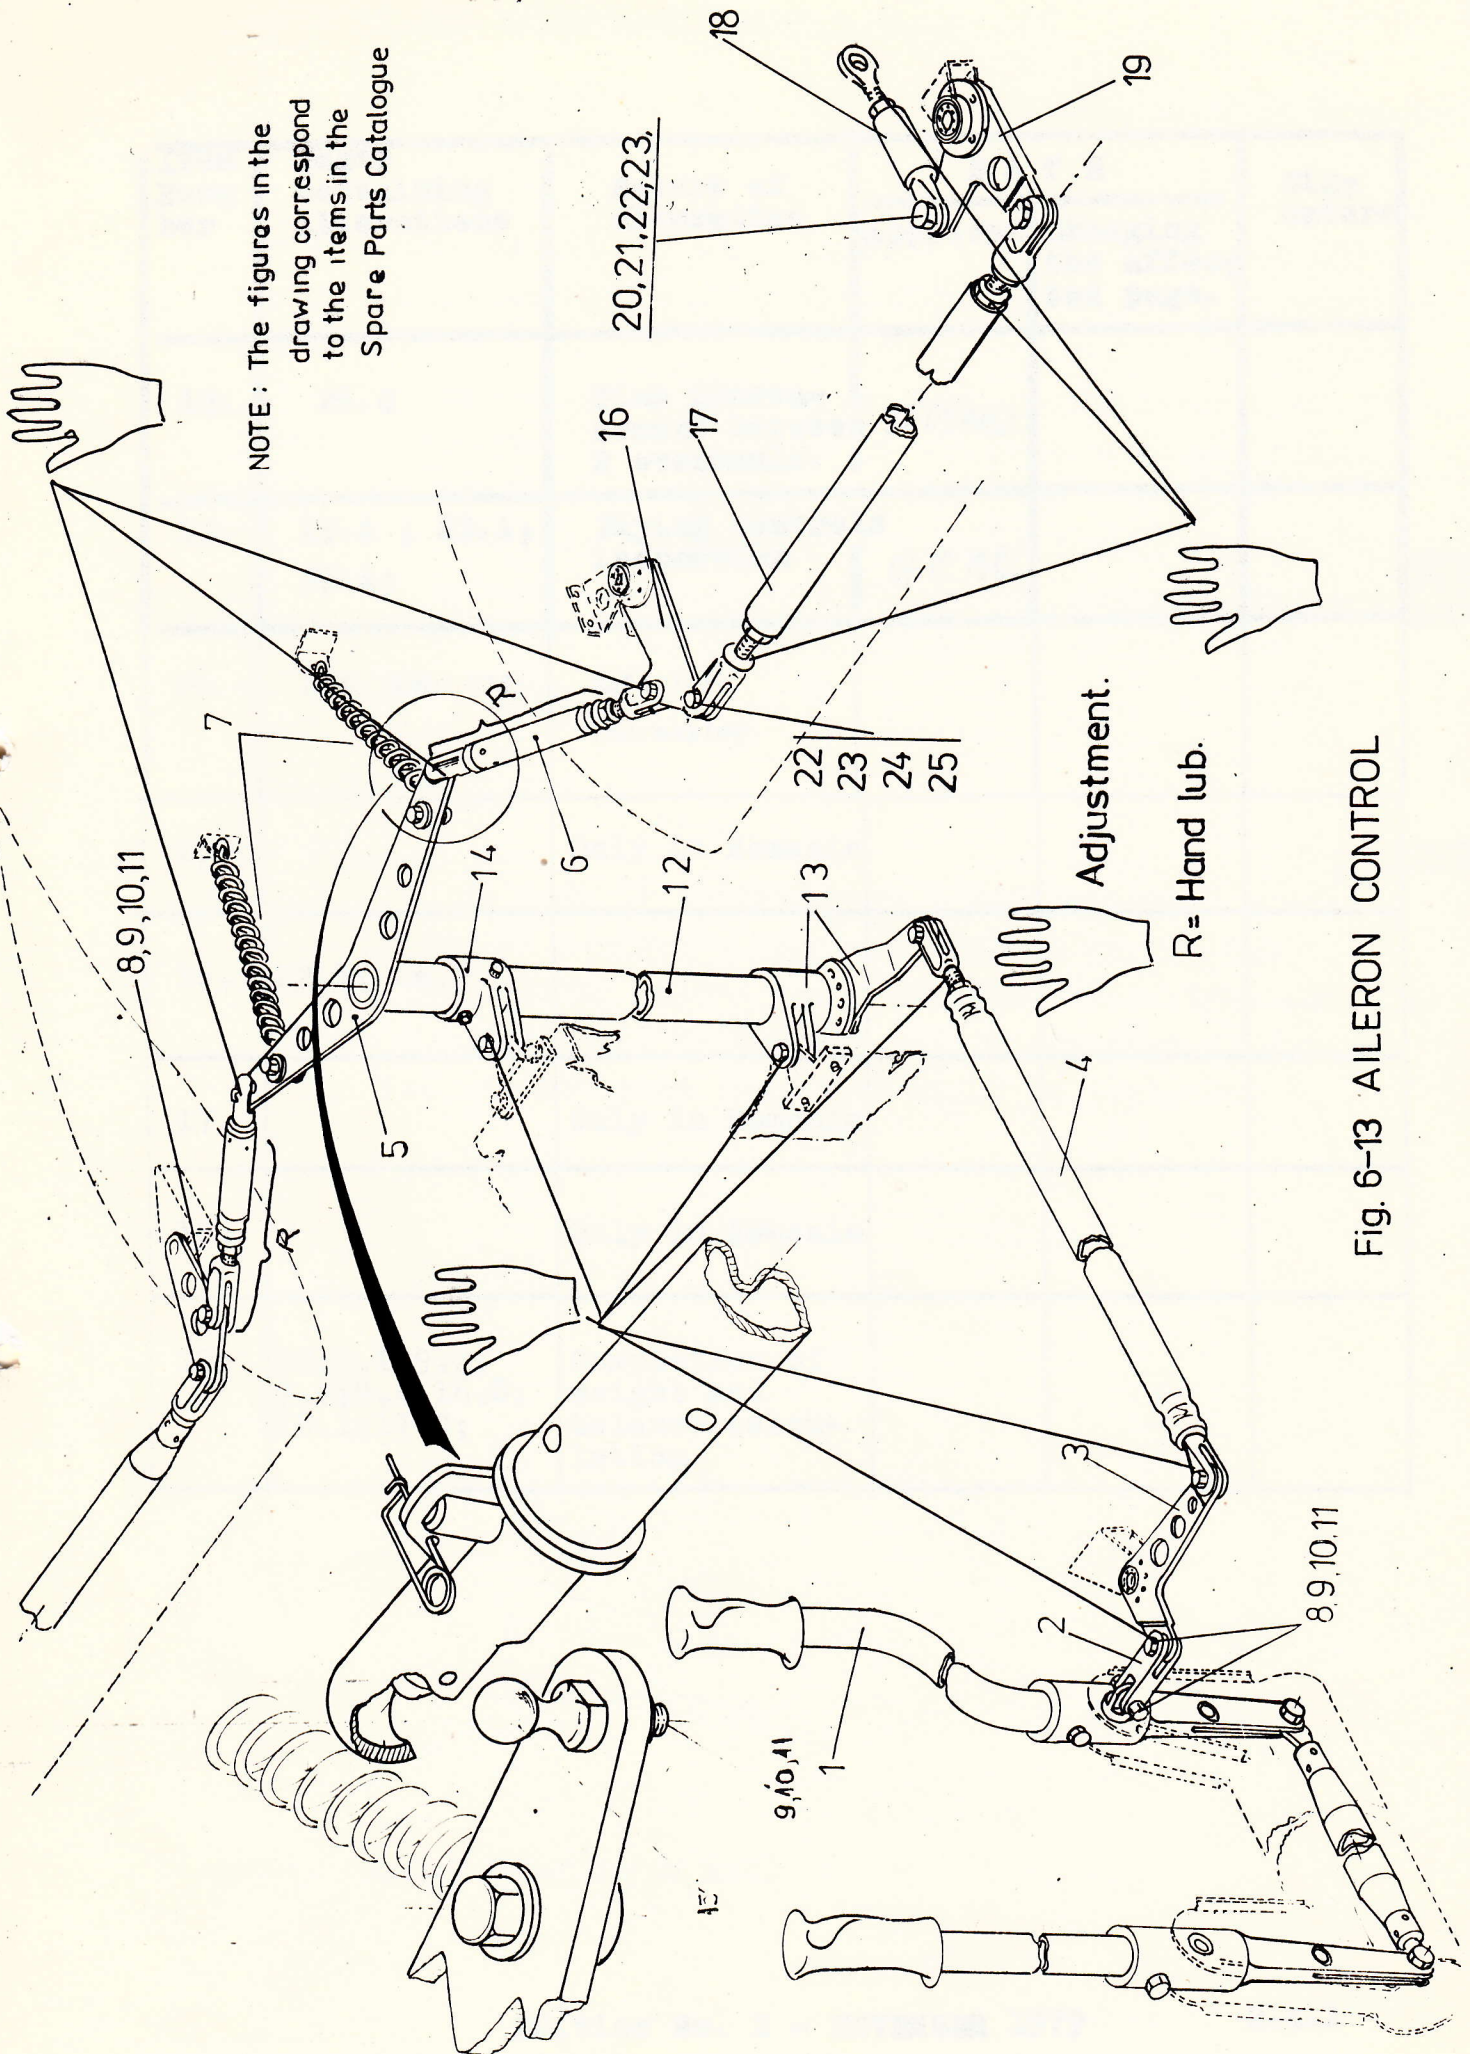
Fig. 6-13 AILERON CONTROL

47 In case of carrying out a tail slide as a result of an incorrect aerobatic manoeuvring, if during the descent the control column was kept near the neutral position, the control rod item 18, page 6.27.A shall be checked before the next flight. If the rod is distorted (bent) it shall be replaced.

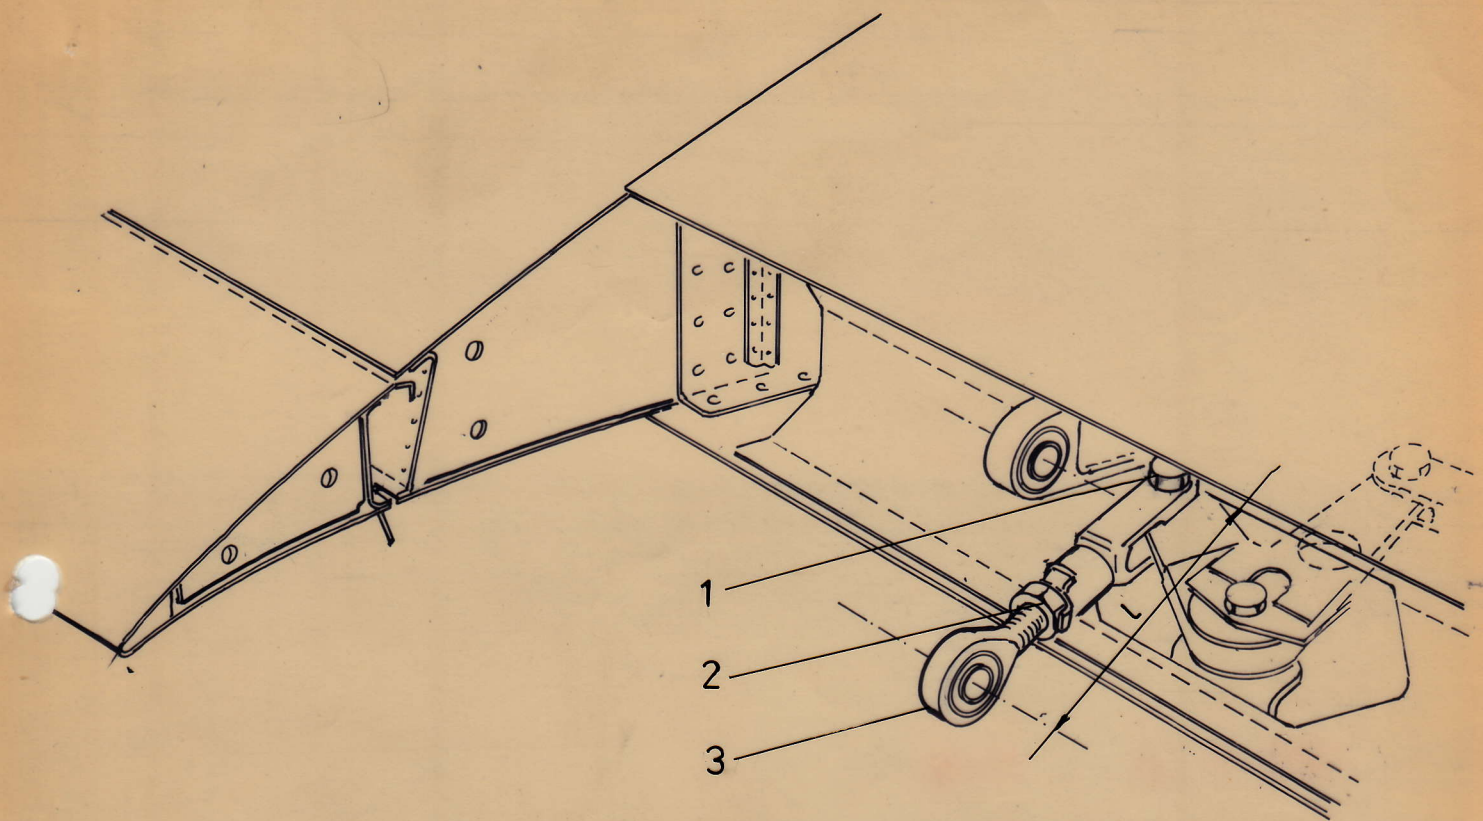
Fig. 1

- In case of incorrect ground handling, if ailerons are forced, or if during an aerobatic flight following a maneuvering incorrectly carried out, the glider performs a tail slide and the control column is slipped from hand or is suddenly deflected up to the limiter, an additional stress may occur within the ailerons control. In this case the hinge moment created can deflect the ailerons upwards, above the rated deflection of 28° and when an angle of approx. 40° is reached, an additional bending stress occurs on the control rod connected to the aileron

Visually check the control rod actuating the ailerons, after its removing from wing and replace it with a new one if bent.

Visually check the control rod, proceeding as follows;
(see figure 1, page 6/6).

- (a). Remove the control rod from the wing lever by unlocking and by removing the nut and screw (item 1) ;
- (b). Measure the control rod length between the attachment pins axles at ends (size "1") - to avoid some possible later adjustments ;
- (c). Unlock the nut (item 2) and remove the eye (item 3).
- (d). Visually check the eye; if bent, replace it with a new one.
- (e). Reassemble the parts, in reverse order, adjusting the rod length to size "1".

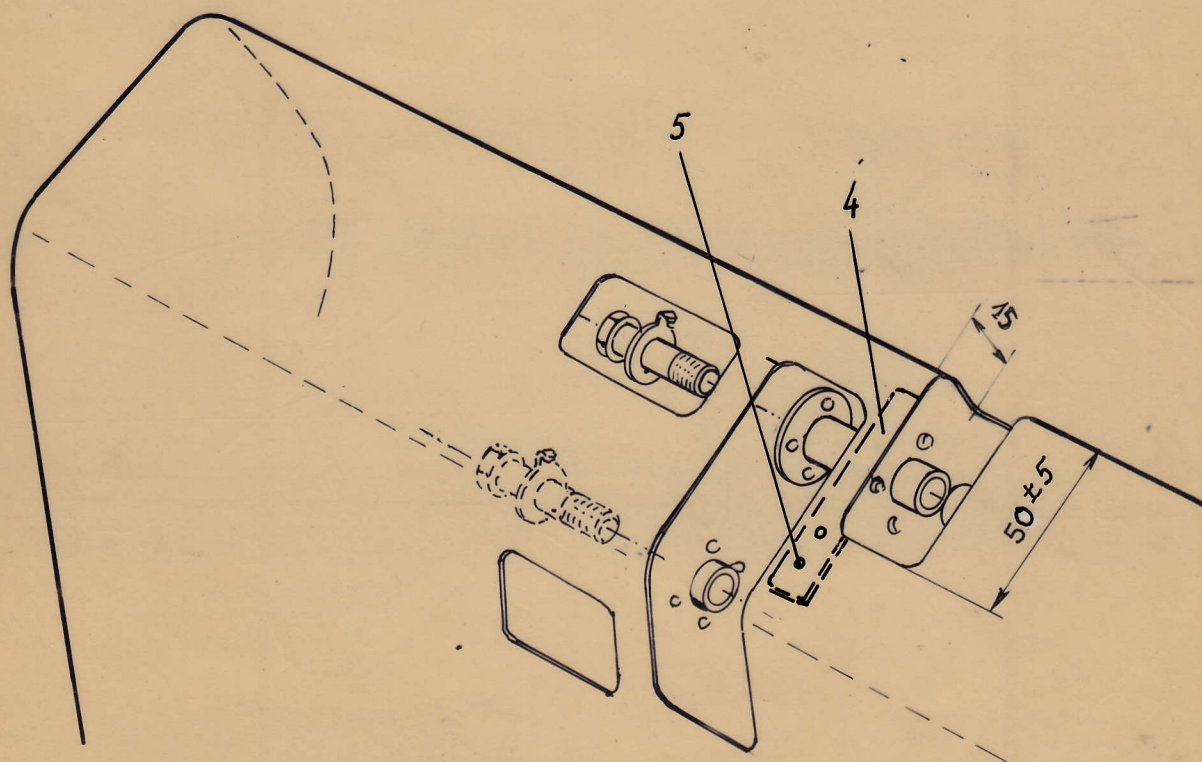
Fig. 2

Enlarge the cut-out in the aileron leading edge (through which the above mentioned rod passes) according to the dimensions on page 6/6 figure 2.

Enlarge the cut-out in the ailerons leading edge to the dimensions indicated on page 6/6, figure 2, by using a mill. Check the doubler item 4 (fig. 2) riveting to the skin. The number of rivets item 5 (fig. 2) shall not be reduced by milling to less than 2 (if required, a new rivet shall be driven in). If the recommended modification is also applied to point C, third paragraph, the original rod is replaced with a new one, (made of steel), after having been adjusted to the length "1". If, applying the point d) above, the eye is found distorted and the Buyer does not possess a spare part, on request, all the rods (made of steel) shall be delivered, applying thus directly the recommended modification.
