# IS-28B2/E0-25 MANDATORY SERVICE BULLETIN

PRODUCT : IS-28B2 GLIDER

SUBJECT : CHECK OF AIR BRAKE CONTROL HANDLES

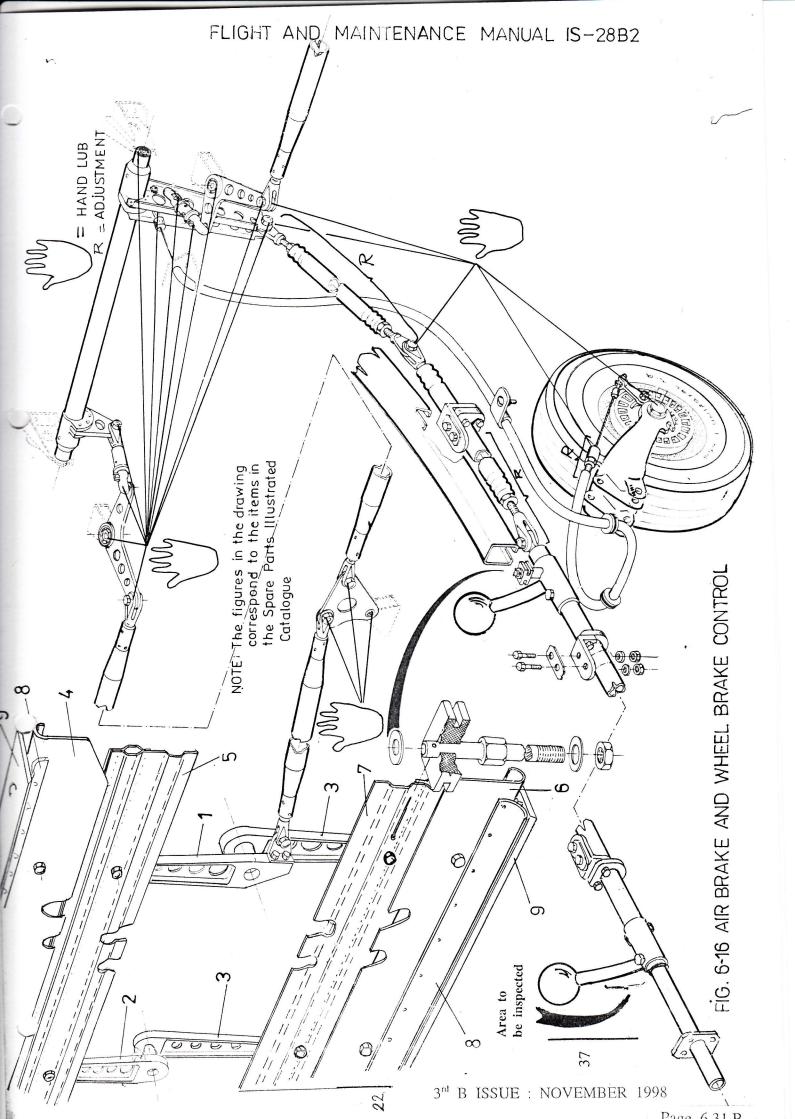
WELDING

Failure of an air brake control handle at the welding seam.

- > Dust the two air brake control handles; if the result is not satisfactory, clean with a soft cloth.
- > Inspect the welding and the adjacent area.

If any suspicions exist, use a penetrant dye. If a crack is detected to one of the two control handles, stop the glider from flight and order new handles to IAR – Braşov.
