MANDATORY SERVICE BULLETIN

IS-28M2/EO-10

PRODUCT : IS-28M2

OBJECT : ADDITIONAL INSTRUCTIONS CONCERNING THE
FLYING CONTROLS CHECK

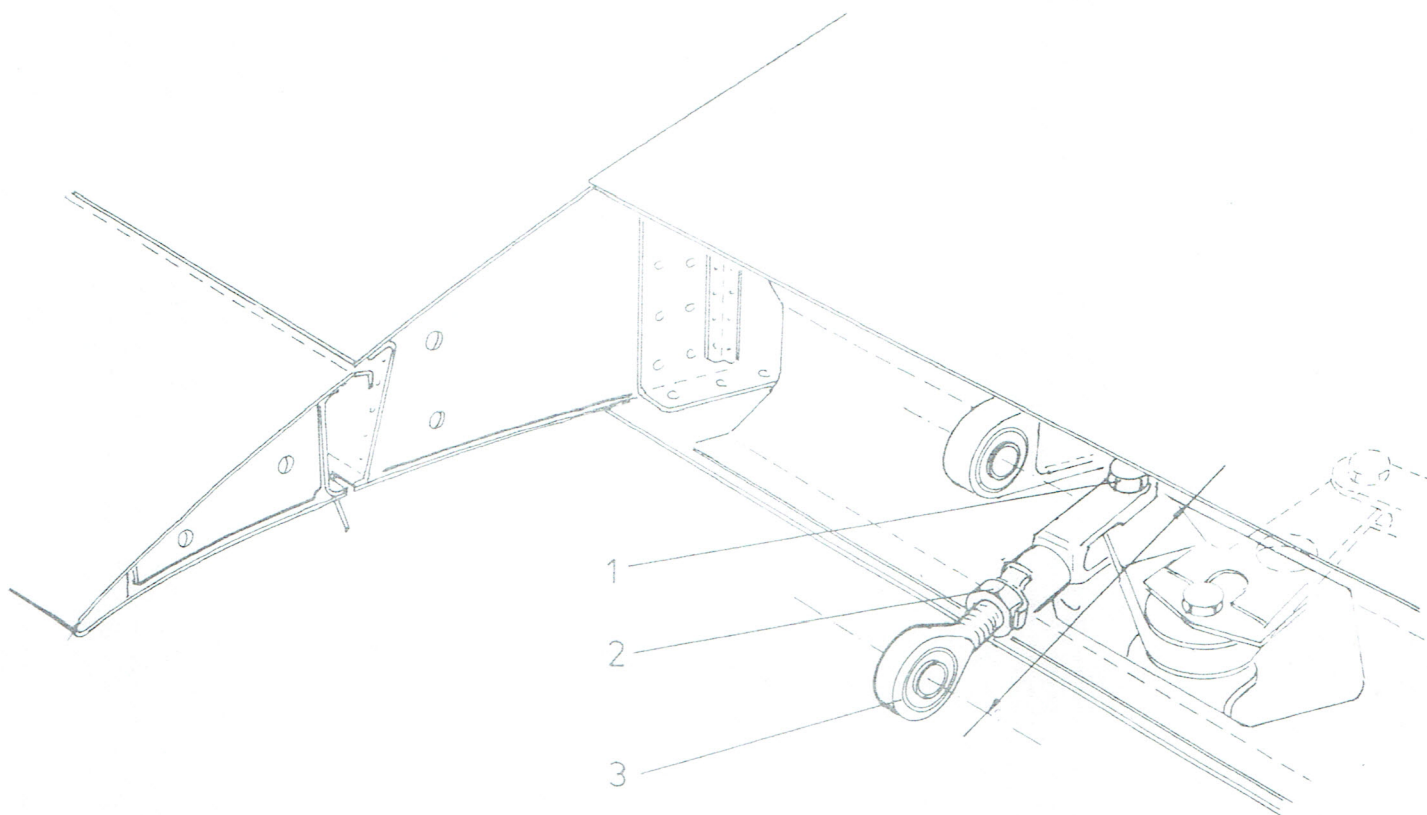
Fig. 1

- In case of incorrect ground handling if ailerons are forced, or if during an aerobatic flight following a maneuvering incorrectly carried out, the glider performs a tail slide and the control column is slipped from hand or is suddenly deflected up to the limiter, an additional stress may occur within the ailerons control. In this case the hinge moment created can deflect the ailerons upwards, above the rated deflection of 20° and when an angle of approx. 40° is reached, an additional bending stress occurs on the control rod connected to the ailerons.

Visually check the control rod actuating the ailerons, after its removing from wing and replace it with a new one if bent.

Visually check the control rod, proceeding as follows; (see Figure 1, page 6/6).

- (a). Remove the control rod from the wing lever by unlocking and by removing the nut and screw (item 1);
- (b). Measure the control rod length between the attachment pins axes at ends (size "1") - to avoid some possible later adjustments ;
- (c). Unlock the nut (item 2) and remove the eye (item 3).
- (d). Visually check the eye: if bent replace it with a new one.
- (e). Reassemble the parts, in reverse order, adjusting the rod length to size "1".
