# **IS-28M2/GR/CO-01**

## **MANDATORY SERVICE BULLETIN**

**PRODUCT** : IS-28M2/GR MOTOR GLIDER

**SUBJECT** : REPLACEMENT OF THE SPECIAL SCREW 28M2.M02.402.20  
FOR PROPELLER PITCH CONTROL

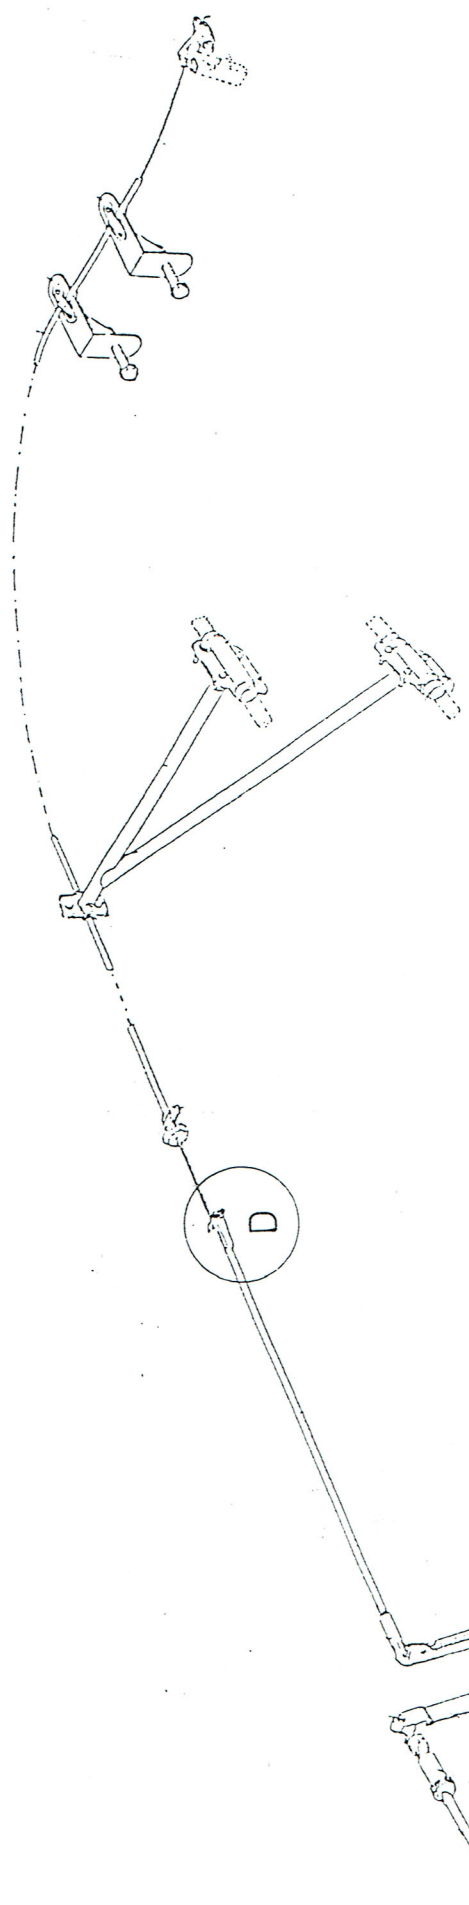
DETALIUL „D”

When mounting the propeller pitch control, a weakening tendency was noticed to the 28M2.M02.402.20 special screw at repeated tightenings of the piano wire locking nut (M5x0.8-3.1).

The modified special screw has the locking part of the piano wire increased from M5 to M6. The nut providing the piano wire tightening is increased from M5 to M6. The washer pressing the piano wire is increased from 5x1 to 6x1.5.

- Dismount the 28M2.M02.402.20 special screw together with the piano wire from the 28M2.M02.162.00 rod assy;
- Dismount the piano wire from the 28M2.M02.402.20 special screw;
- Mount the piano wire on the 28M2.M02.402.20 modified special screw;
- Mount the 28M2.M02.402.20 modified special screw together with the piano wire on the 28M2.M02.0162.00 rod assy;

Dismount the piano wire attached to the 28M2.M02.402.20 screw by removing the M5x0.8 locking nut and 5x1 washer and shifting the screw towards the free end of the piano wire. Fix the piano wire on the 28M2.M02.402.20 modified special screw, shifting the screw on the piano wire in the previous position, by tightening the M6x1 nut and 6x1.5 washer. Tightening is carried out until a safe locking of the piano wire is obtained.
