Service Bulletin

Doc.-No.: SB-IS-28B2-AR-01

Service Bulletin SB-IS-28B2-AR-01 applies to all IS-28B2 gliders.

In a number of gliders cracks were detected in the upper stringer of the rear fuselage.

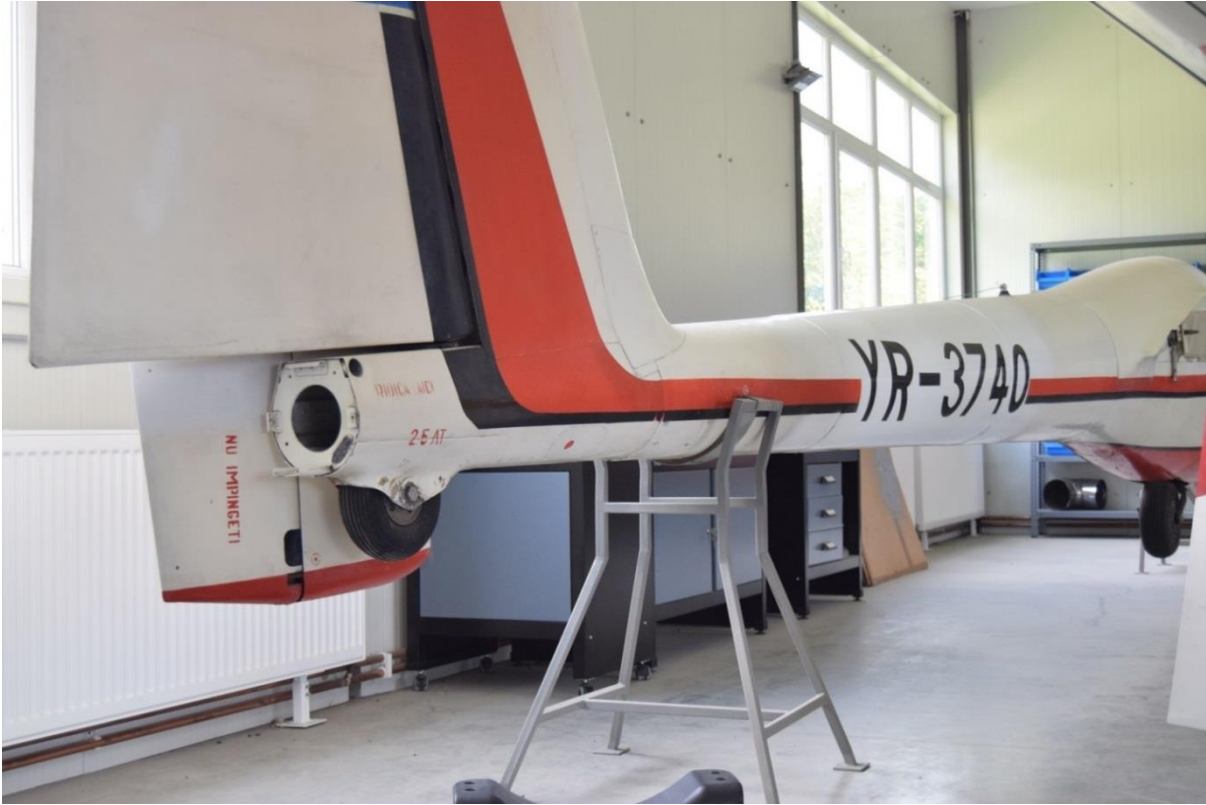
Photo 1

1) Raise the rear fuselage to facilitate easy access to the maintenance panel, for example like in photo 1.

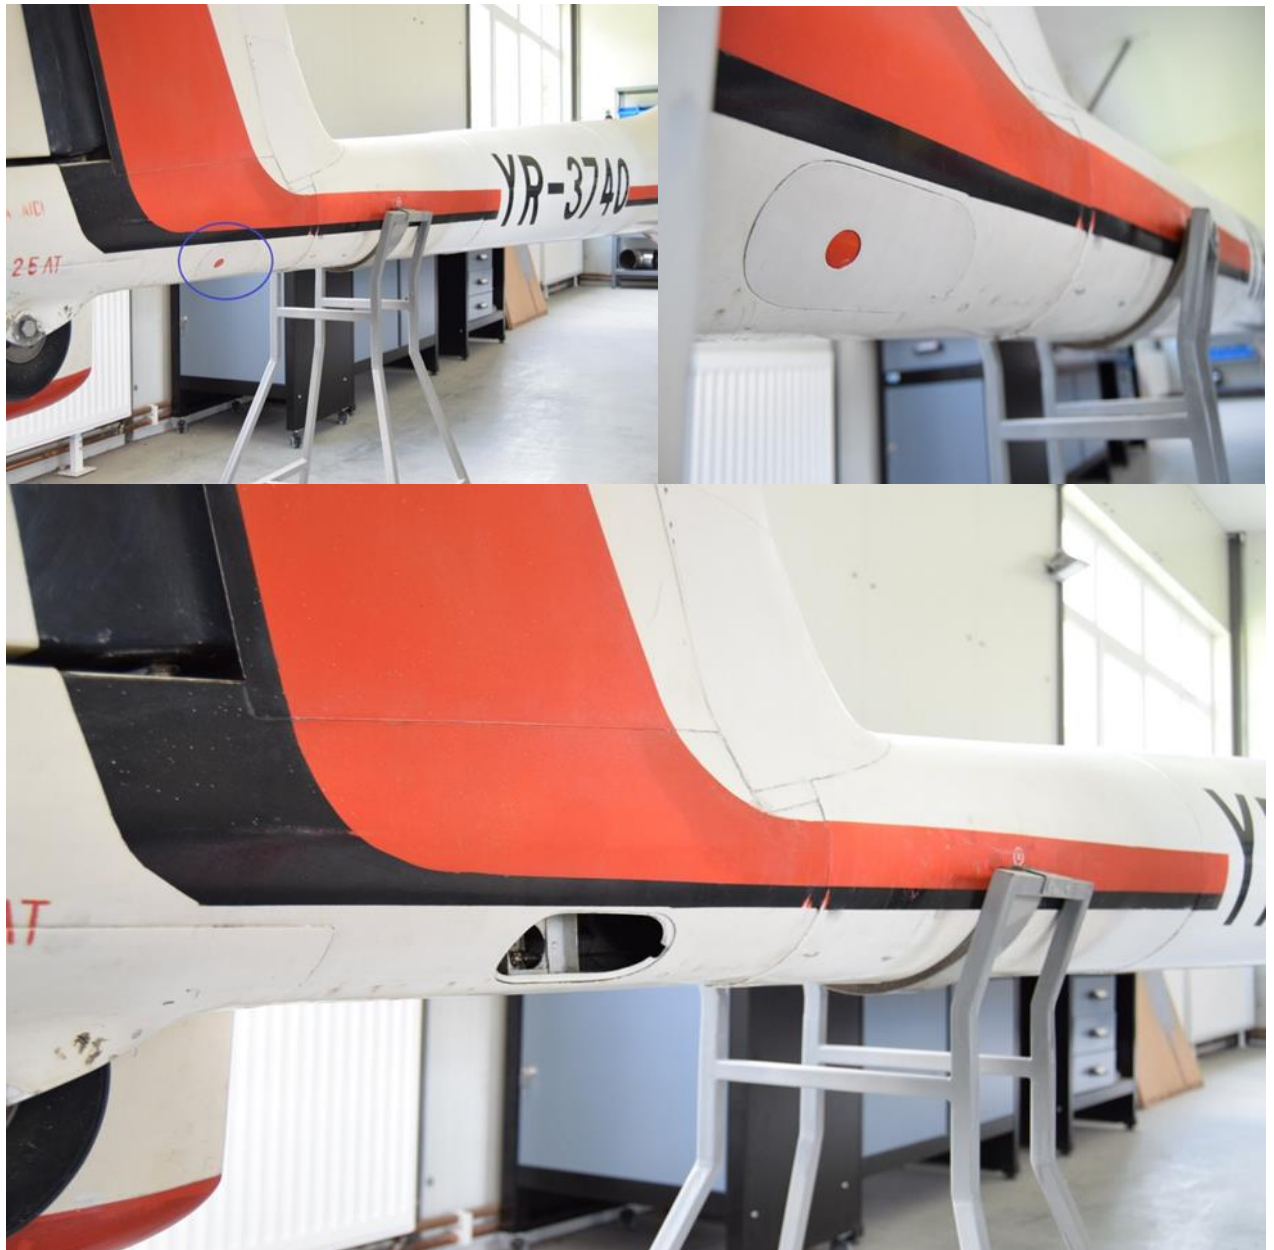
Photo 2

- 2) Remove the maintenance panel to access the maintenance cut out from the bottom of the fuselage, right side, under the vertical stabilizer.

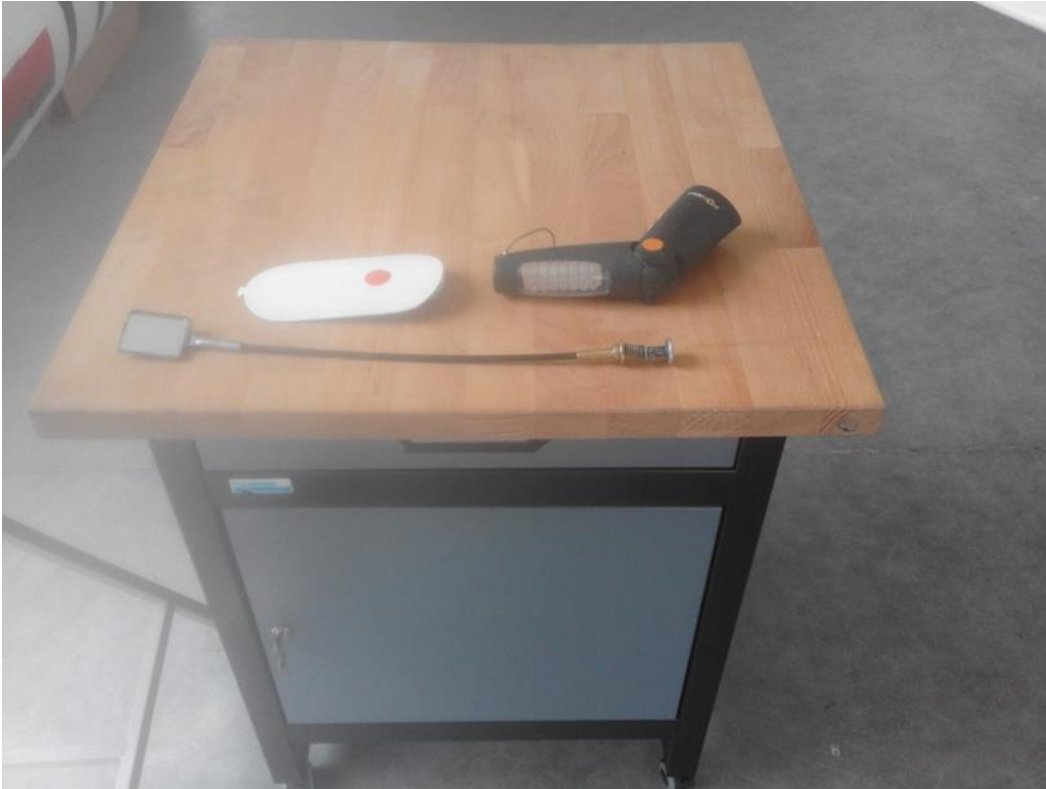
Photo 3

- 1) Use a bright flashlight to inspect the inside of the fuselage.
- 2) Using a retractable mirror and/or a borescope camera (photo bellow), the zone shall be inspected.
