MANDATORY SERVICE BULLETIN

IS-28B2/EO-12

PRODUCT : IS-28B2

OBJECT : ADDITIONAL INSTRUCTIONS CONCERNING THE
FLYING CONTROLS CHECK.

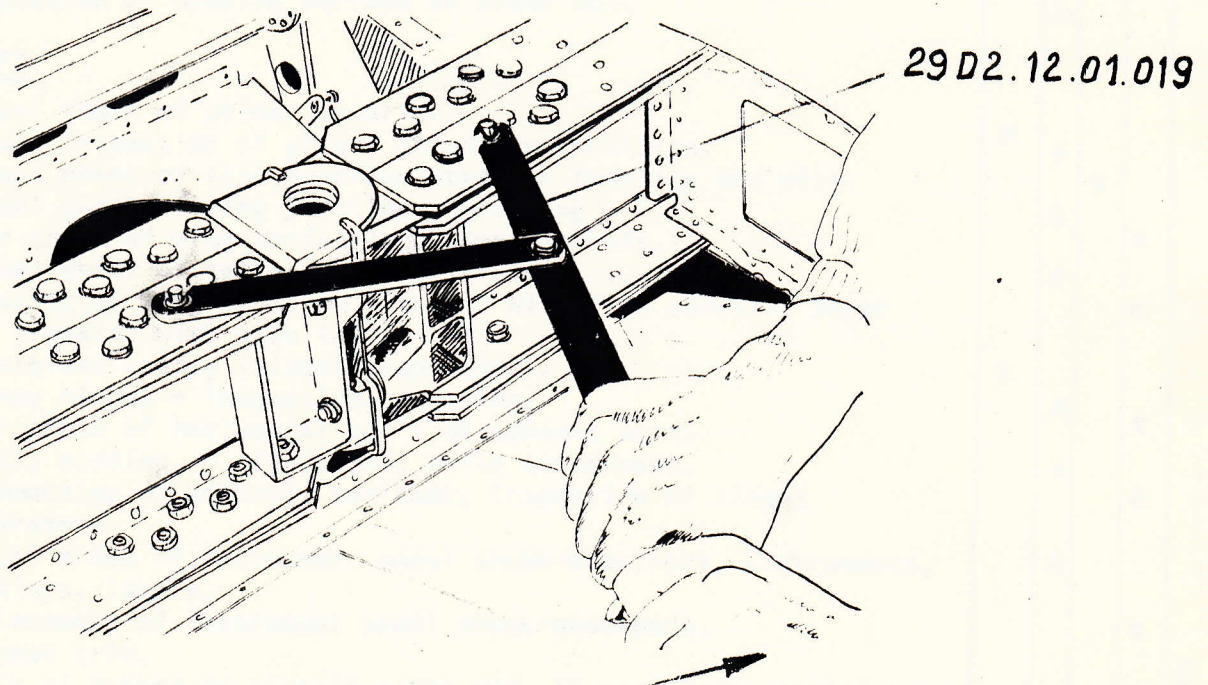
For easier wing jointing the 29D2.12.01.019 wing jointing device will be used from sailplane no.24 onwards. The device is coupled on two pins on the left and right wing (see drawing). Actuating the handle the wing joint will be achieved.
