Service Bulletin

No. SB-IS-28B2-AR-03

Modifying the Maintenance program and increasing TBO from 1200 flight hours / 7500 landings to
1400 flight hours / 8400 landings

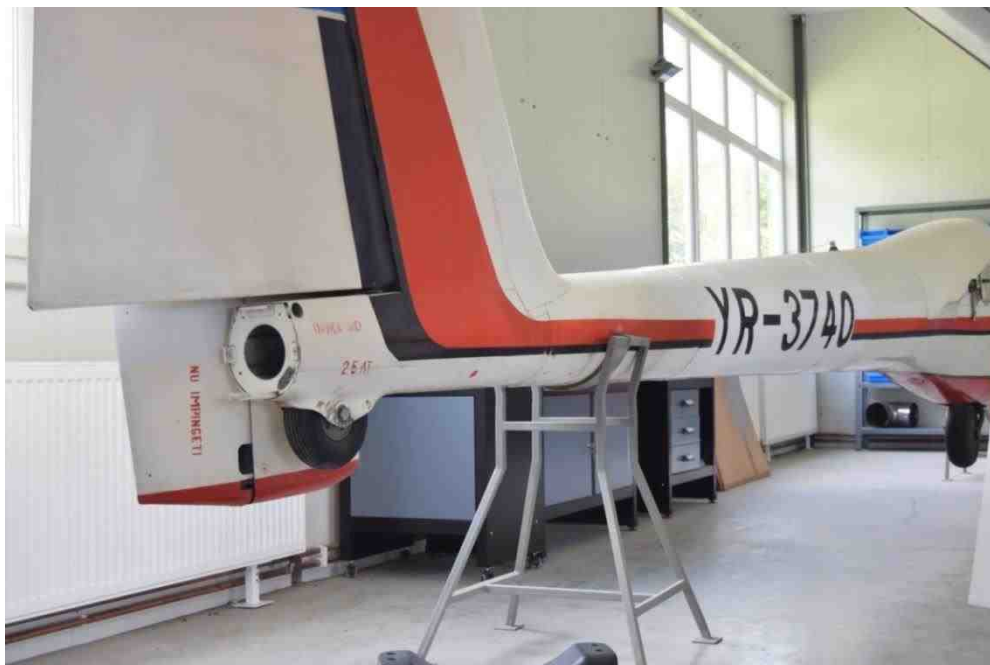
Photo 1

1. Preparation of required tools;
2. Raise the rear fuselage to facilitate easy access to the maintenance panel, for example like in photo 1.
