## Service Bulletin

No. SB-IS-28B2-AR-03

Modifying the Maintenance program and increasing TBO from 1200 flight hours / 7500 landings to  
1400 flight hours / 8400 landings

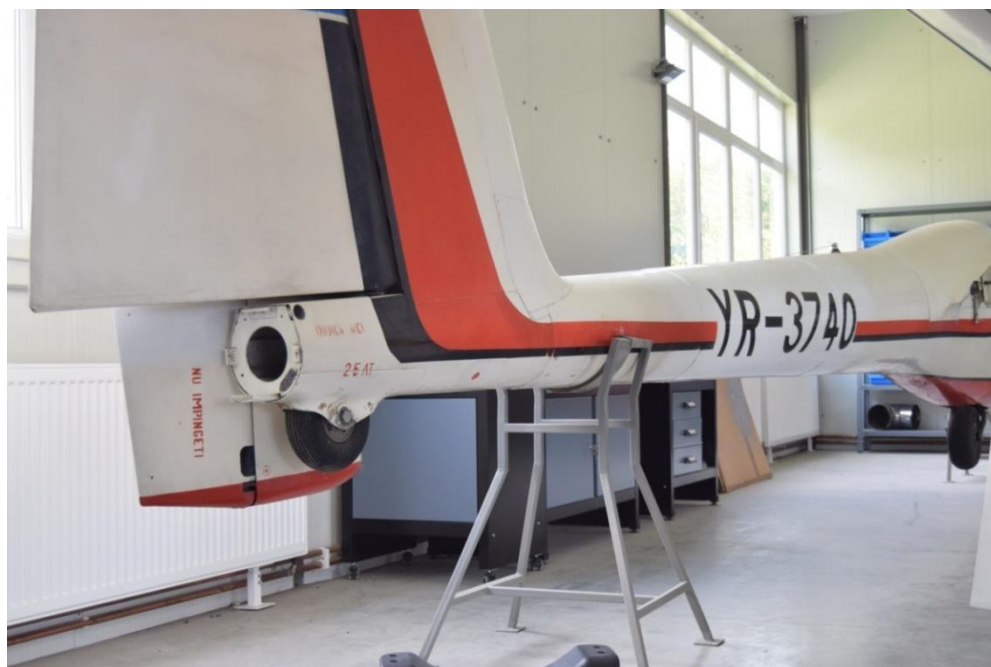
Photo 1

1. Preparation of required tools;
2. Raise the rear fuselage to facilitate easy access to the maintenance panel, for example

like in photo 1.
